Guidance and Lessons Learned from Monitoring Completed Navigation Projects

Compiled by Lyndell Z. Hales and Donna L. Richey

June 2004

Final report

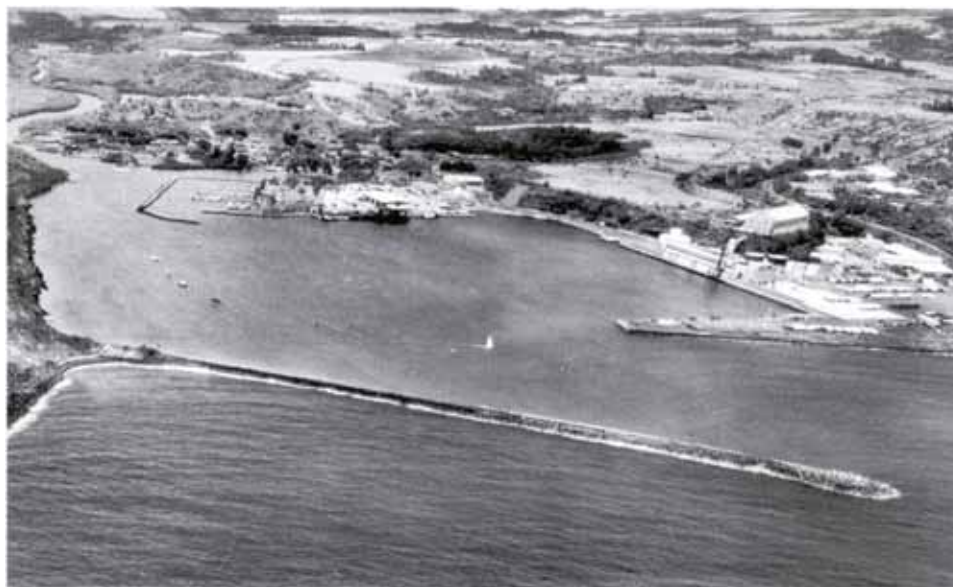
Figure 1. Nawiliwili Harbor, Kauai, HI (after Bottin and Meyers 2002a)

- a. The Nawiliwili Harbor breakwater has been repeatedly subjected to major storm events, including three hurricanes, during its 70-year history. As a result, extensive breakwater damage has occurred. Major rehabilitations were completed in 1959, 1977, and 1987. The structure was originally armored with keyed-and-fitted stone but now has several sizes of tribar and dolos concrete armor units. The Nawiliwili breakwater is one of the most complex rubble-mound structures the Corps of Engineers has constructed. No sound, quantifiable data relative to the movement or positions of the concrete armor units had been obtained for the structure prior to this study.

- b.* A total of 70 broken/cracked concrete armor units were identified in the 1995 survey, and 77 broken/cracked units were identified in 2001. However, high-wave action during the 1995 waking inspection prevented a close examination of armor units at the water's edge. Of the seven additional broken units in 2001, six were located along the water's edge and may have been broken in 1995 as the result of the excessive wave action. Therefore, it appears that minimal armor unit breakage occurred between 1995 and 2001.

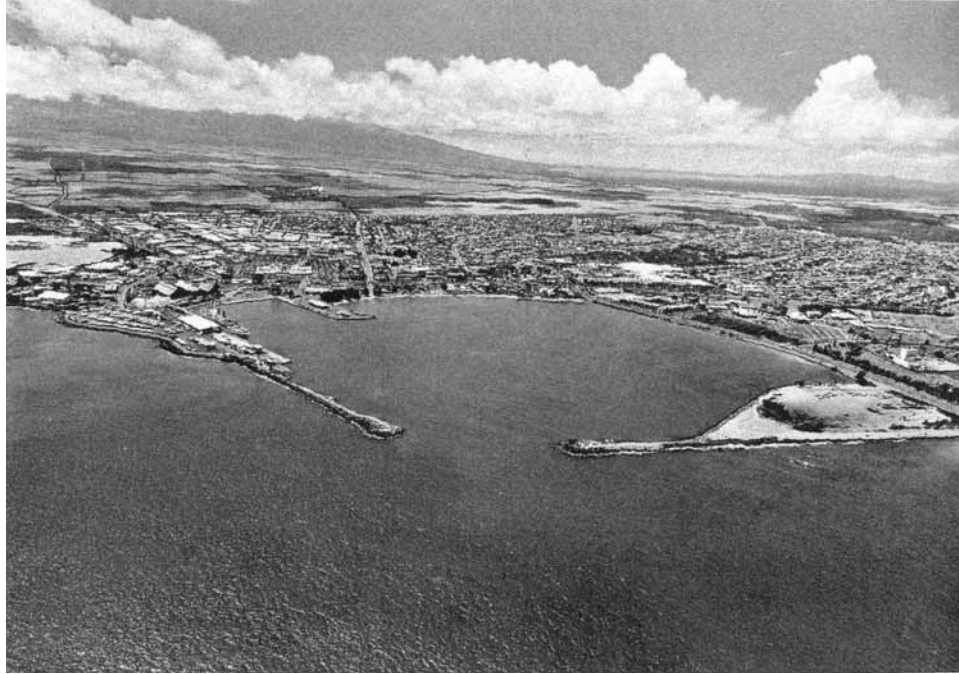
Figure 2. Kahului Harbor, Maui, HI (after Bottin and Meyers 2002b)

breakwater. An inspection in 1973 revealed that 29,965-kg (33-ton) tetrapods on the sea side of both heads had sustained considerable damage and they, along with the 7,265-kg (8-ton) stone areas on both trunks, were in need of repair.

- b. For the west breakwater, however, comparisons of target coordinates showed relatively close agreement with those obtained in 1993. The average movement of all targets in both the horizontal and vertical directions was less than 0.02 m (0.5 ft). Considering the movements of targeted armor units' centroids, average movements in both the horizontal and vertical directions were less than 0.2 m (0.6 ft) for the east breakwater, and less than 0.1 m (0.4 ft) for the west breakwater.
- c. A total of 29 broken/cracked armor units on the east breakwater and 58 on the west breakwater were identified during the 2001 survey. These data establish a base from which to evaluate future breakage in subsequent surveys. The areas of concentrated breakage on the Kahului east and west breakwaters should be inspected annually to monitor any increase in breakage and thus reduction in stability.

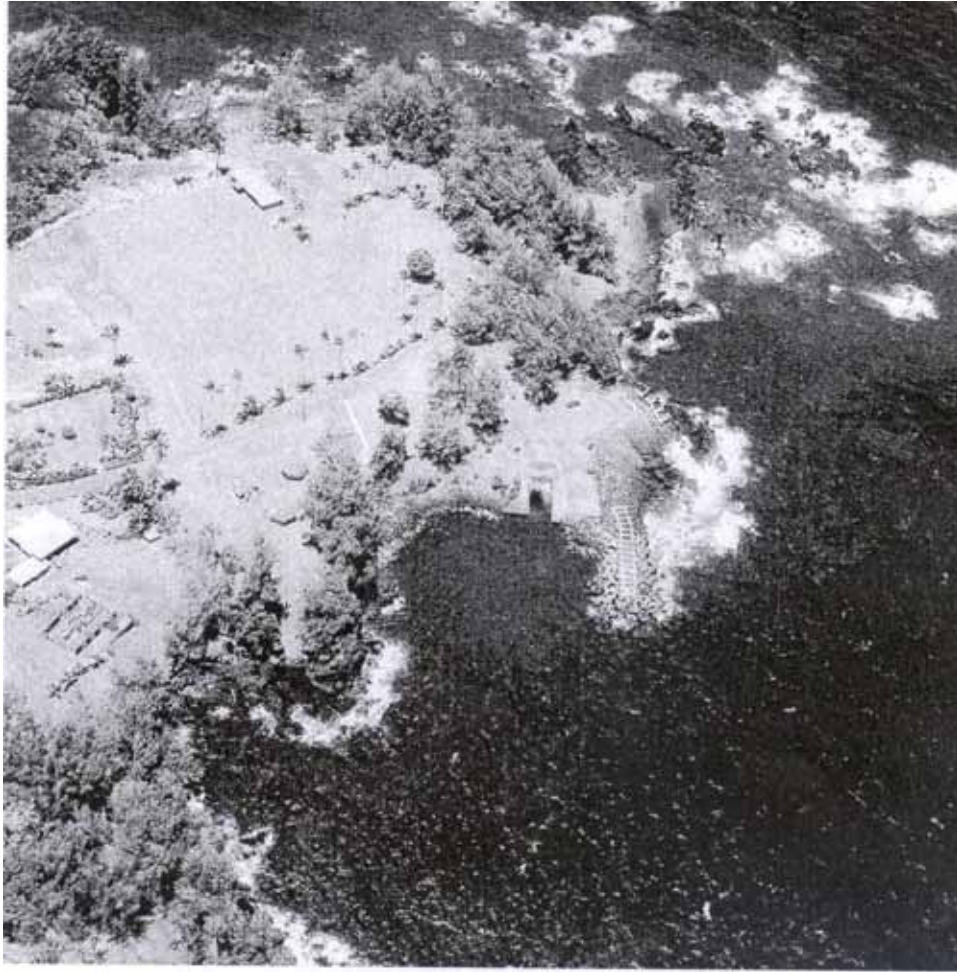
Figure 3. Laupahoehoe Boat Launching Facility, HI (after Bottin and Meyers 2002b)

- d. During testing of the method, it was observed that very little change, in regard to armor unit movement, occurred during the 1991-1993 monitoring period, but this should be anticipated, as the wave climate to which the structures were exposed was very mild during this time. Low-level helicopter surveys of concrete armor units revealed no breakage on the Laupahoehoe breakwater.

- a. Similar data were obtained during 2001 and compared with the 1993 data. An analysis of these data indicated negligible movement on the breakwater.
- b. Average target movement in both the horizontal and vertical directions was less than 0.1 m (0.2 ft). Considering the movements of targeted armor units' centroids, average movements in both the horizontal and vertical directions were around 0.03 m (0.1 ft) for the Laupahoehoe breakwater.
- c. No broken/cracked armor units were found on the Laupahoehoe breakwater.

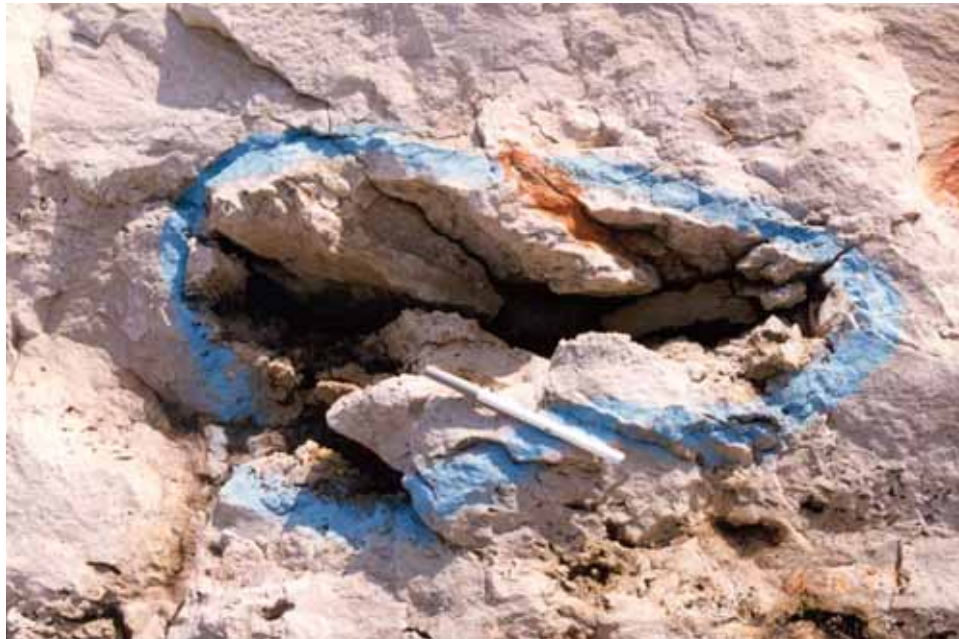
Figure 37. Great Lakes breakwater stone deterioration (after Richards et al. (in preparation))

A survey of breakwater stone structures in the Great Lakes in 1990 indicated various degrees of excessive and premature stone deterioration (Figure 37). In some stones, the damage was significant and required costly rehabilitation of the structures far in advance of the expected economic life of the structures. Other stones were apparently performing well. The study initiated an effort to determine practical ways to reduce the amount of stone deterioration, lengthen the economic life of coastal structures, and to reduce the annual cost of maintenance. The study also compared changes in performance of the stone that resulted from inherent weaknesses such as diagenetic or depositional environment (facies) and fractures resulting from extraction methods at the quarries.
